# Static Electric Motor Testing Diagnostic Chart

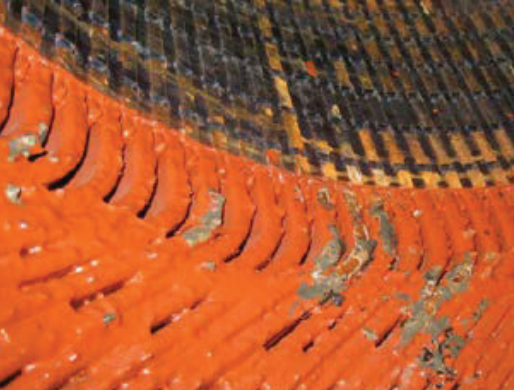
| High Voltage Testing | | | |
|---|---|---|---|
| <b>Low PI</b><br> | Contamination, insulation deterioration | Clean / dry insulation system / overhaul | Motors with IR values < (1 MegOhm per 1000V of nameplate + 1Megohm) @40°C should not be started until the IR value has been improved.<br><br>Test voltage for MegOhm insulation resistance testing is typically at or below the motor's nameplate rating. |

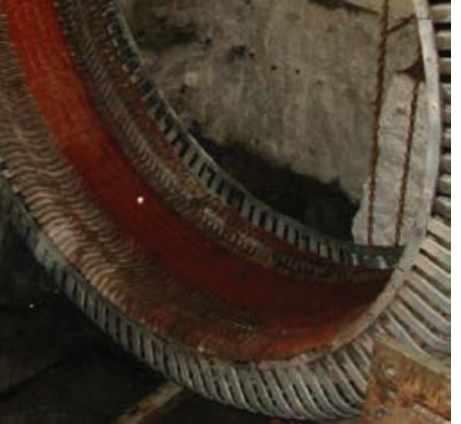
| High Voltage Testing | | | |
|---|---|---|---|
| <b>Low MegOhm on Hipot</b><br> | Groundwall contamination, insulation deterioration | Evaluate PI/DA for evidence of moisture and contamination. Clean and inspect motor or send out for overhaul if efforts prove ineffective. | When performing insulation testing at higher voltages it is possible that surface leakage paths will increase causing lower insulation resistance values during high potential testing. Contamination effects of this kind typically show up as a single linear step change in current and not a continual exponential increase. |
